**Subject: September 15, 2009, Compliance Evaluation Inspection - Asarco East Helena Plant (Direct Smelt Building and Adobe Shed)**

**FIELD INVESTIGATION REPORT**

**SITE:** Asarco - East Helena Facility

**PURPOSE:** Compliance Evaluation Inspection

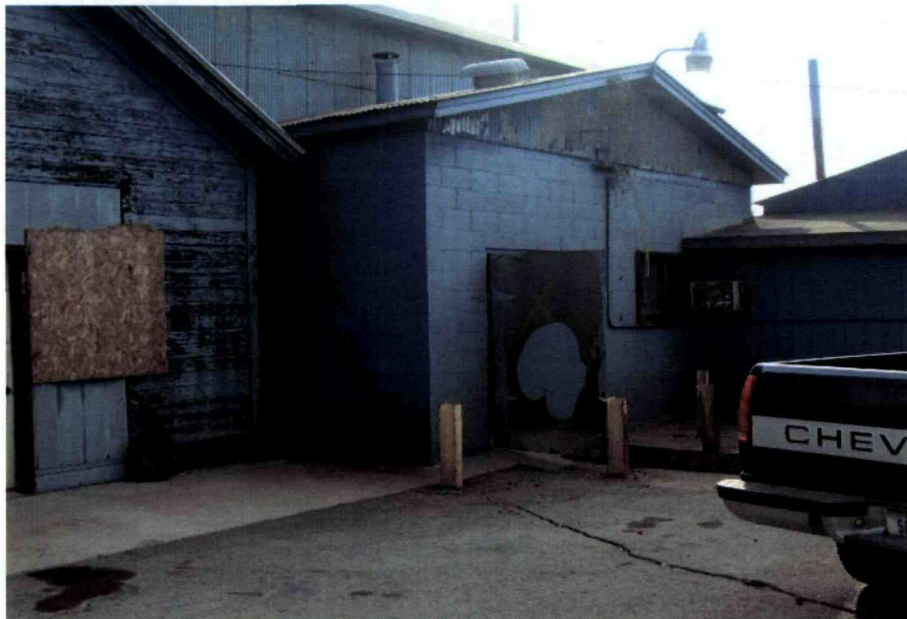
This photo shows the exterior and entrance to the Adobe Shed.

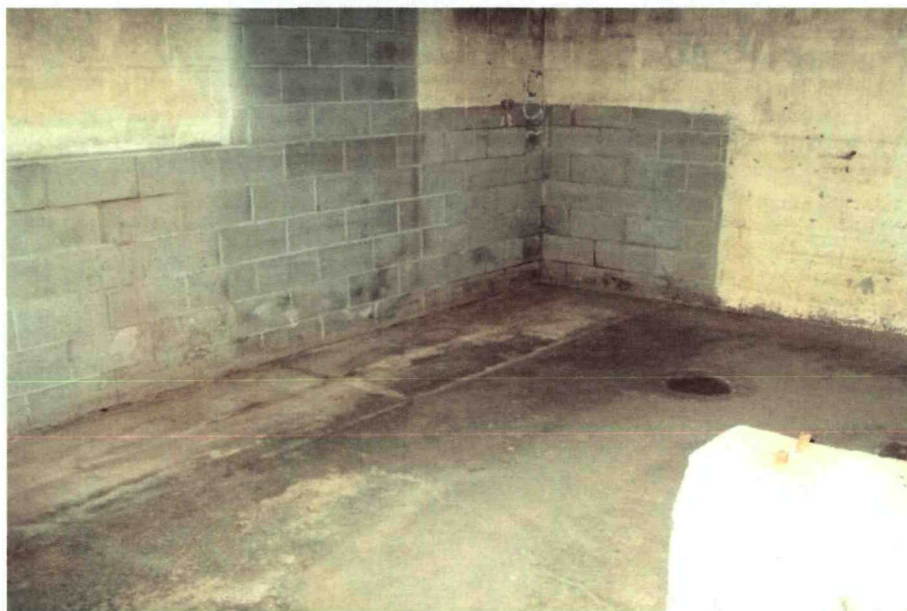
PHOTO #: ASARCO\_09258-002  
DATE: September 15, 2009

Looking inside the Adobe Shed from the entrance door.  
All interior surfaces of the shed were vacuum cleaned  
and washed down with high pressure, low volume water.

Note: The Adobe Shed was used to mix adobe clay for  
use in the blast furnace operations.

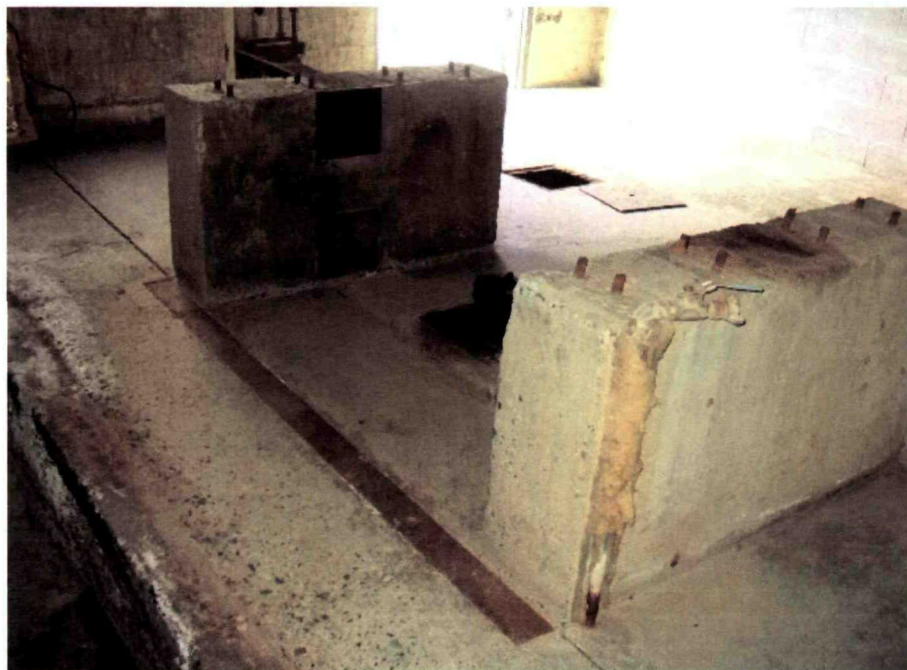
PHOTO #: ASARCO\_09258-003  
DATE: September 15, 2009

Another photo of the interior of the Adobe Shed.

The concrete support walls shown here in this photo  
were washed down with high pressure, low volume  
water.

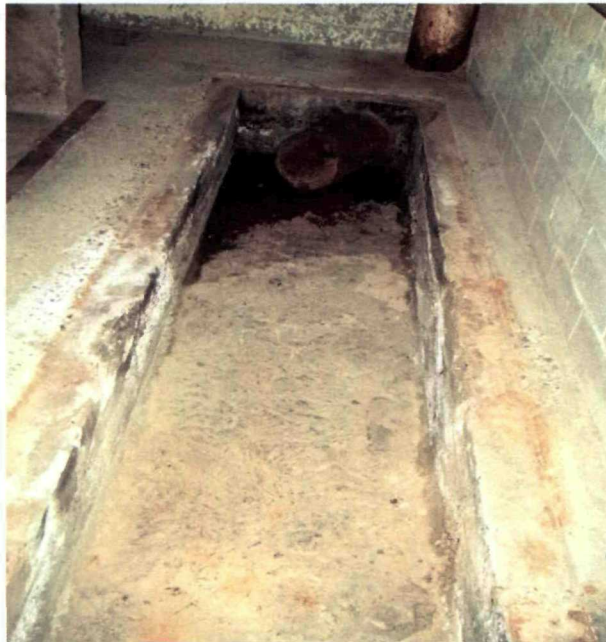
PHOTO #: ASARCO\_09258-004  
DATE: September 15, 2009

This photo shows the concrete trench in the floor of the Adobe Shed.

The trench was vacuumed and washed down with high pressure, low volume water.

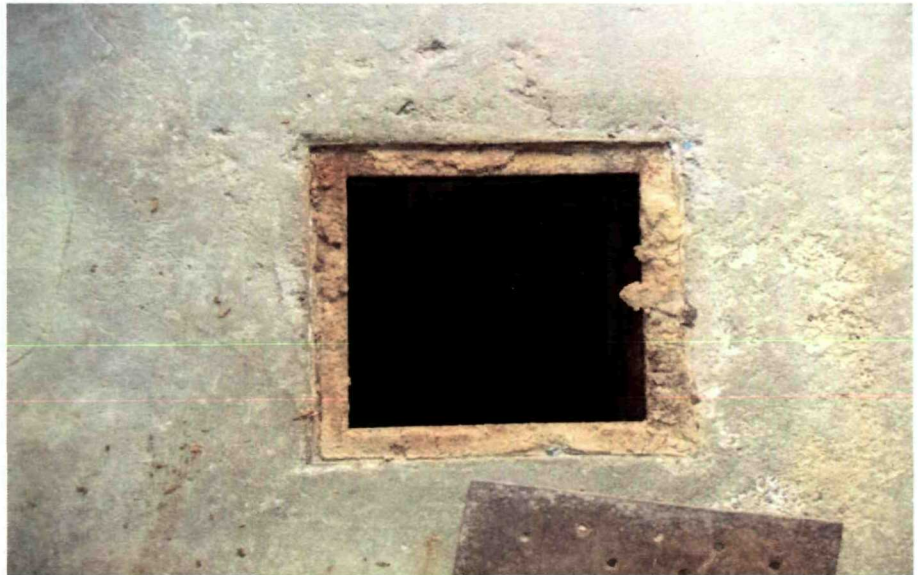
PHOTO #: ASARCO\_09258-005  
DATE: September 15, 2009

I noted during the inspection that two floor drains in the shed had not been cleaned. After the inspection, Mr. Nickel sent me an e-mail on September 15, 2009, letting me know that Asarco vacuum cleaned the two floor drains in the adobe shed. The material removed resembled dried adobe clay. They collected about one vacuum cleaner tank volume. (Refer to photos 005 and 006 in the attached photolog.)

This photo shows one of two floor drains in the Adobe Shed. At the time of the inspection, the floor drains had not been cleaned.

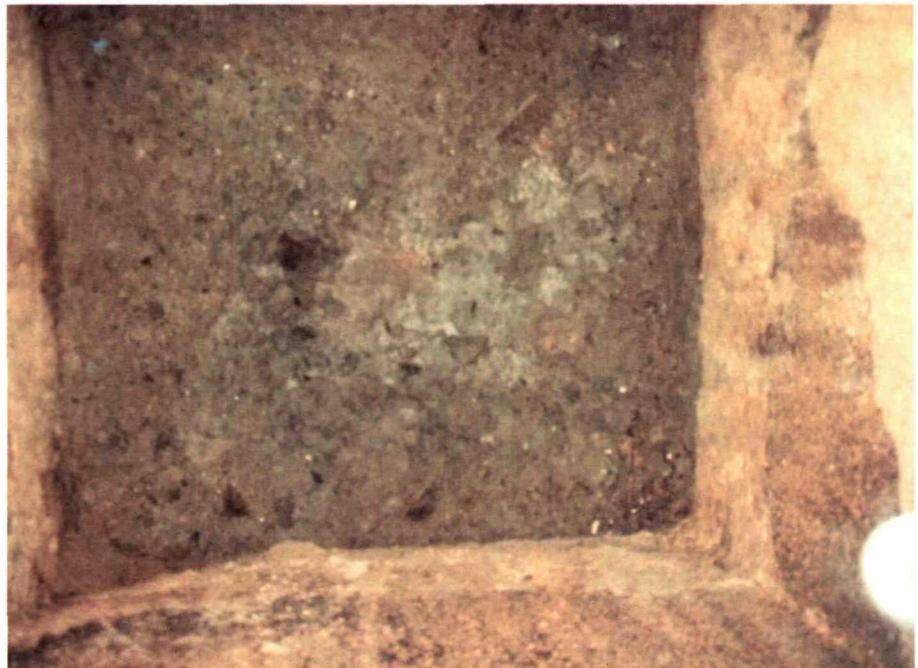
PHOTO #: ASARCO\_09258-006  
DATE: September 15, 2009

Looking inside one of the floor drains in the Adobe Shed before it was cleaned.

Asarco personnel cleaned the drains after the inspection and removed about one vacuum tank of dried adobe clay.

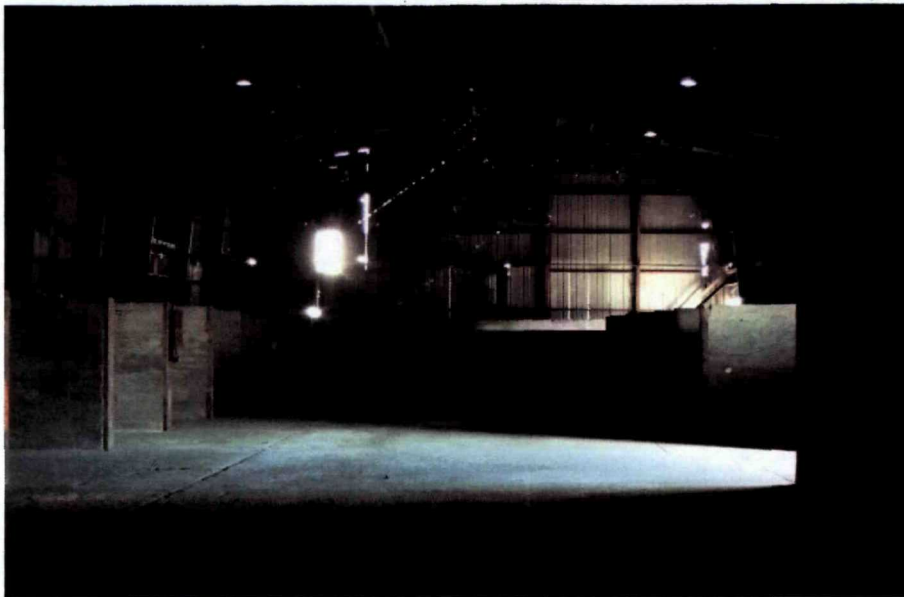
PHOTO #: ASARCO\_09258-007  
DATE: September 15, 2009

At the time of the inspection, IRS Environmental personnel had finished cleaning the Direct Smelt Building (DSB) as shown in this photo.

It appears that all the interior surfaces of the building to include the roof and ceiling beams, wall supports and former ore storage bins were vacuum cleaned and washed down with high pressure, low volume water.

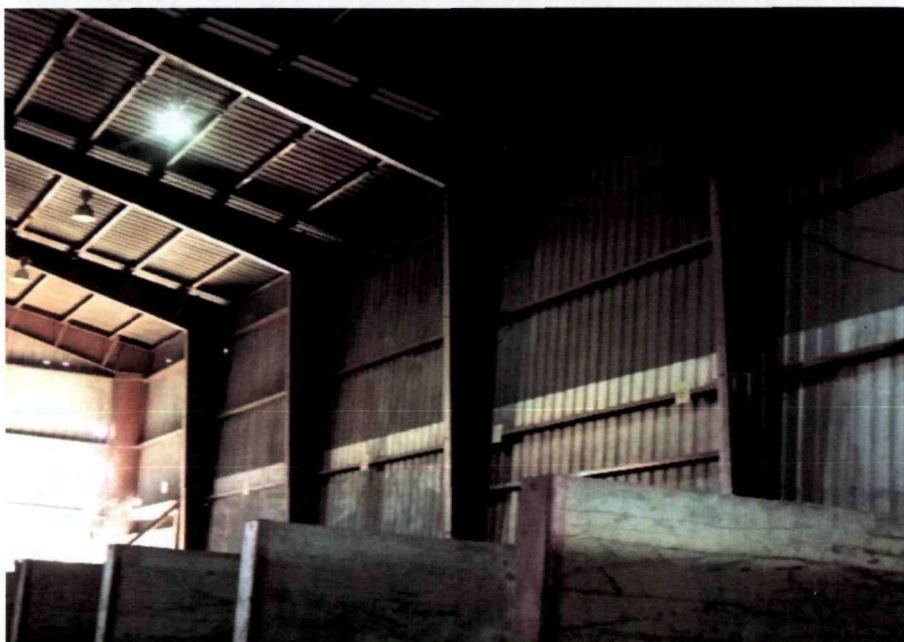
PHOTO #: ASARCO\_09258-008  
DATE: September 15, 2009

Another photo of the interior of the DSB that shows the roof and ceiling beams, wall supports and a portion of the ore storage bins.

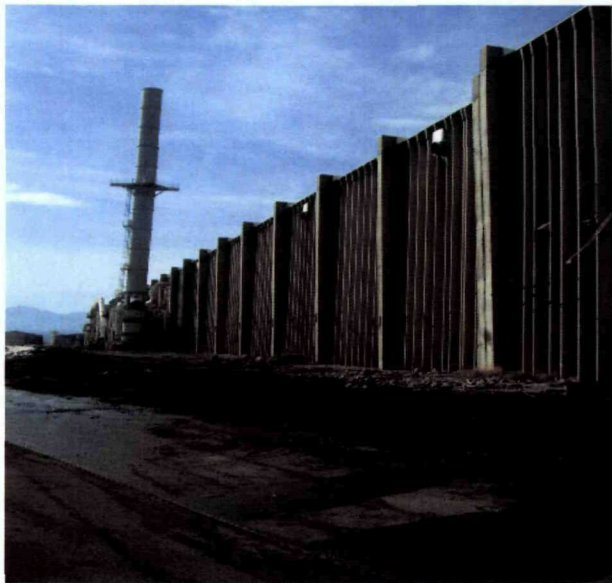
PHOTO #: ASARCO\_09258-013

CSHB: *Currently being cleaned.* At the time of the inspection, some of the exterior baghouses and ventilation ductwork that had been previously cleaned had been demolished and sent off for metal scrap recycling. (See photo 013 in the attached photolog.)

At the time of the inspection, some of the exterior ductwork and bag houses had already been removed from the wall of the Concentrate Storage and Handling Building (CSHB) as shown in this photo.

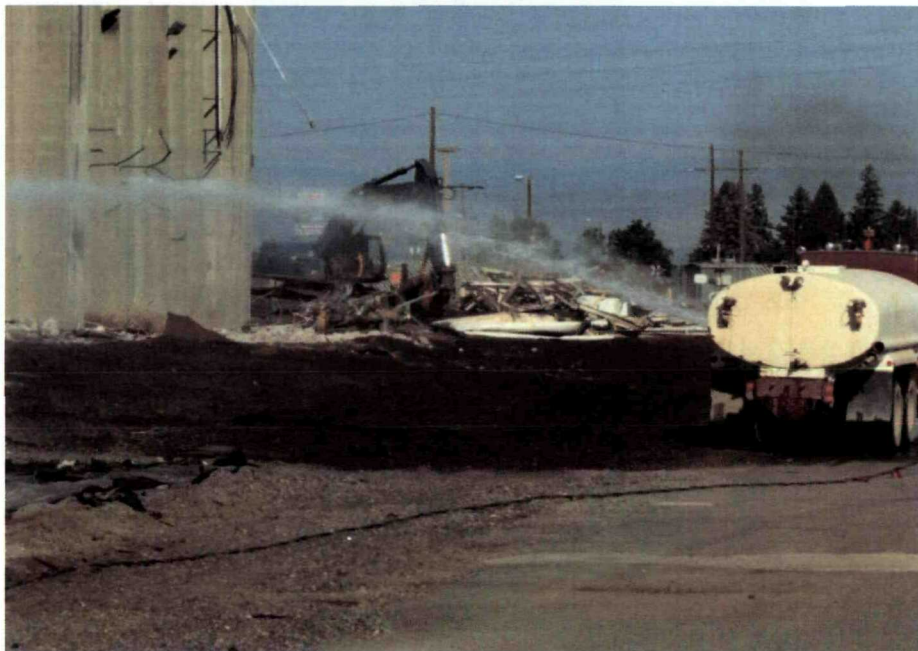
PHOTO #: ASARCO\_09258-014

This photo shows a water truck putting water on the ground in anticipation on where the CSHB stack will fall.

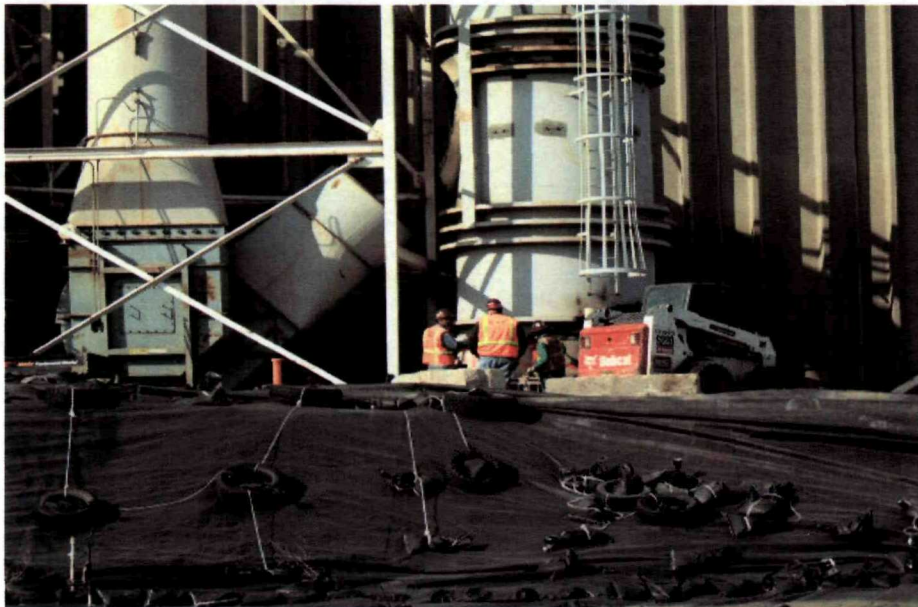
PHOTO #: ASARCO\_09258-015

As shown in this photo, CWC personnel were using cutting torches to cut the CSHB stack from its base on the north side of the CSHB.

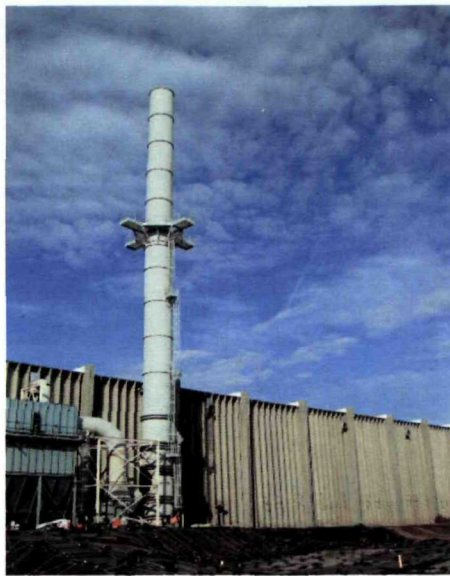
PHOTO #: ASARCO\_09258-016  
DATE: September 15, 2009

This is probably one of the last photos of the CSHB ventilation stack prior to demolition. The stack came down about a minute later after this photo was taken.

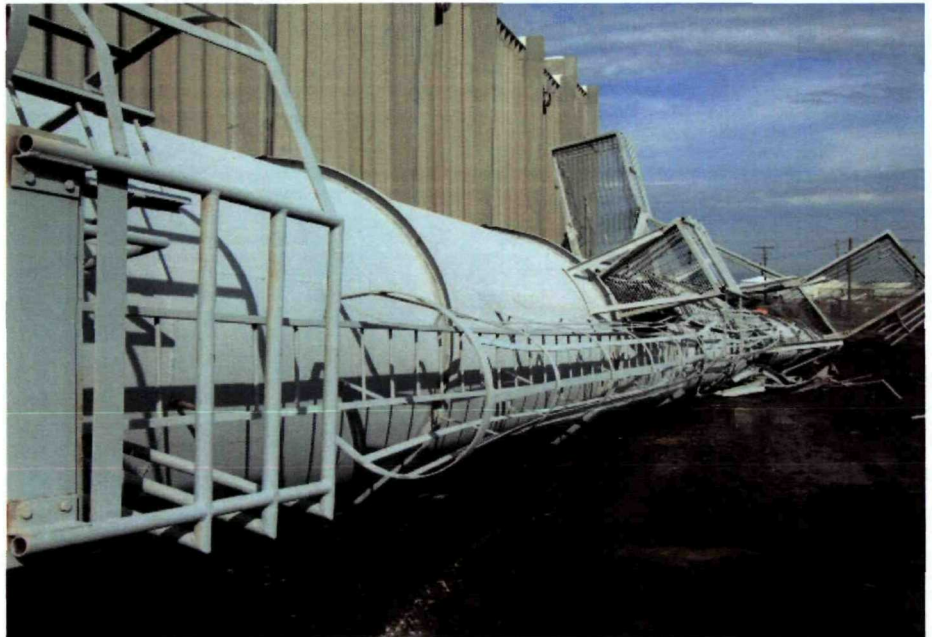
PHOTO #: ASARCO\_09258-017  
DATE: September 15, 2009

The CSHB stack came down exactly where the demolition crew wanted it to fall.

Note: Very little stack debris dust was observed when the stack hit the ground.

Most, if not all, of the stack was metal which was sent off for metal recycling after CWC ensured that the metal was free of any hazardous debris.

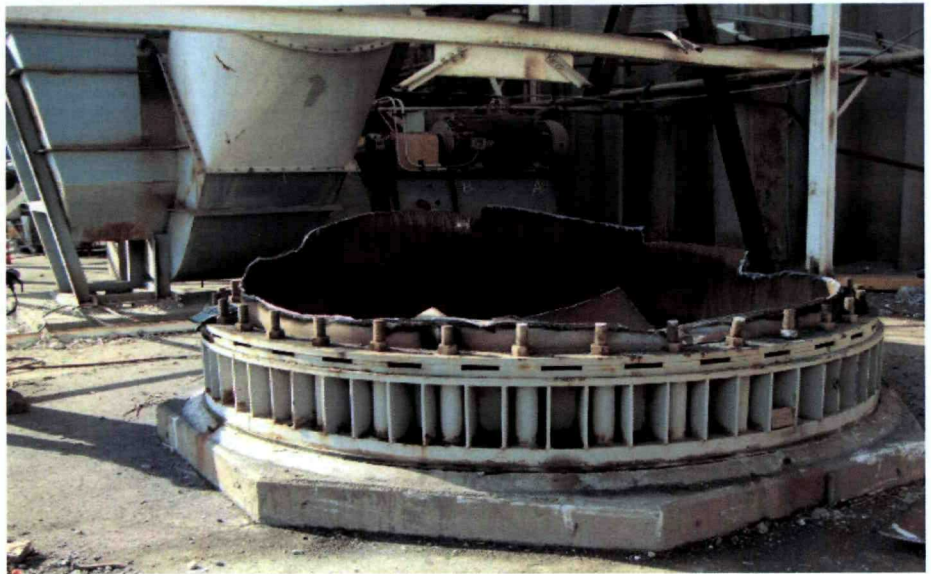
PHOTO #: ASARCO\_09258-019  
DATE: September 15, 2009

All that was left of the CSHB stack was the stack base as shown in this photo.

The base was dismantled and the metal was sent off for metal recovery.

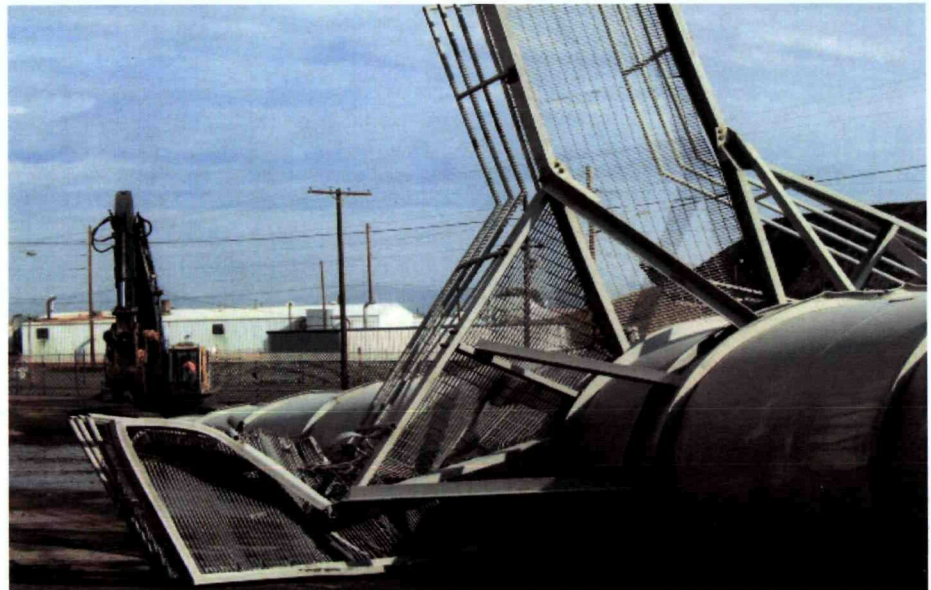
PHOTO #: ASARCO\_09258-020  
DATE: September 15, 2009

Another photo of the CSHB stack.

Note that the equipment used to rip and tear the stack apart was on its way when the photo was taken.

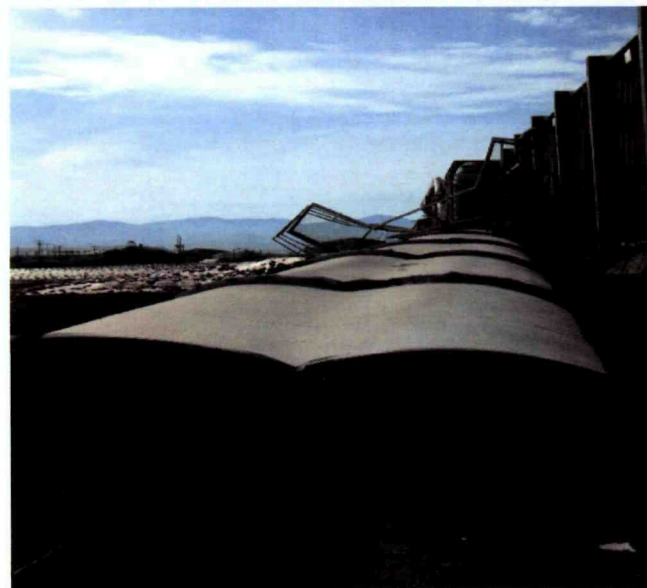
PHOTO #: ASARCO\_09258-021  
DATE: September 15, 2009

This photo shows the viewer the collapsed CSHB stack from the top of the stack to the base.
